GOOD HARBOR BAY WATERSHED

PROTECTION PLAN

August 10th, 2015

Written By: Good Harbor Bay Watershed Steering Committee, and Yarrow Brown, Leelanau Conservancy

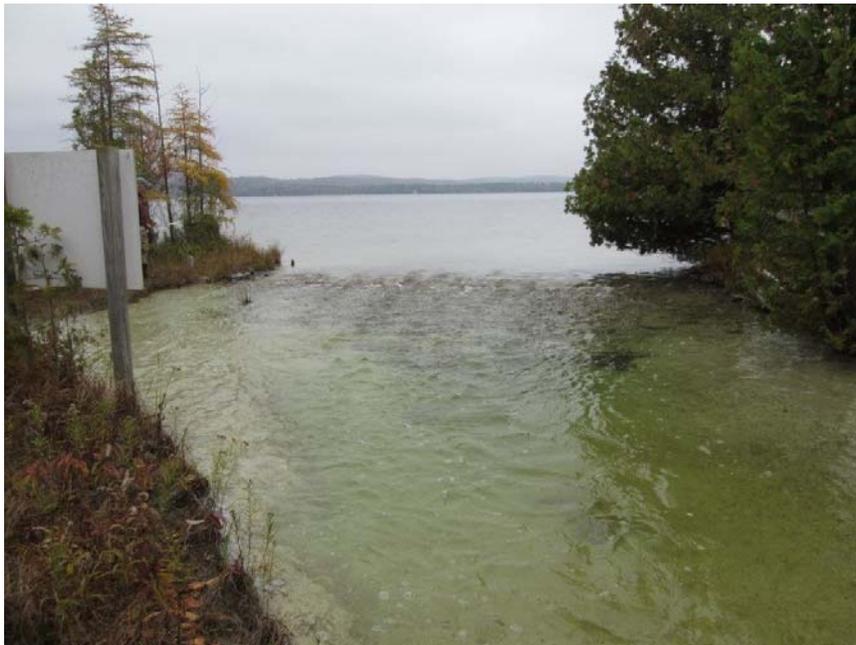
Figure 3: Shalda Creek outlet to Little Traverse Lake

Below and on the next few pages are a few current and historical photos of the Lime Lake outlet to Little Traverse Lake (Shalda Creek) and Little Traverse Lake shoreline as well as the culvert on the west end of Little Traverse Lake and the culvert on County Road 669.

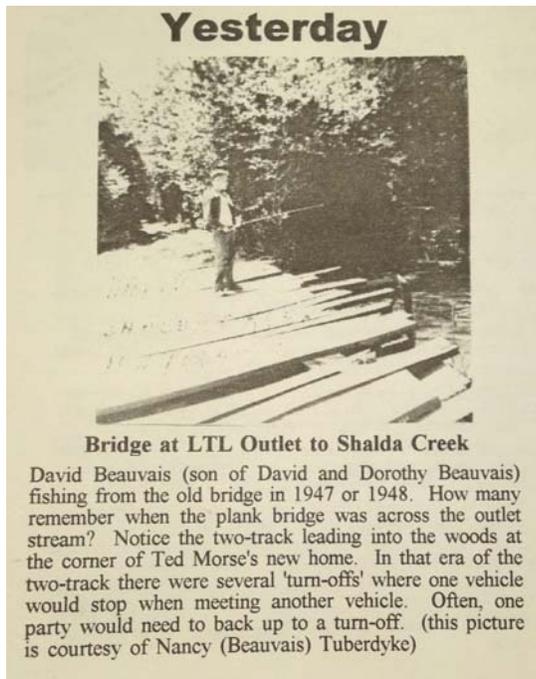
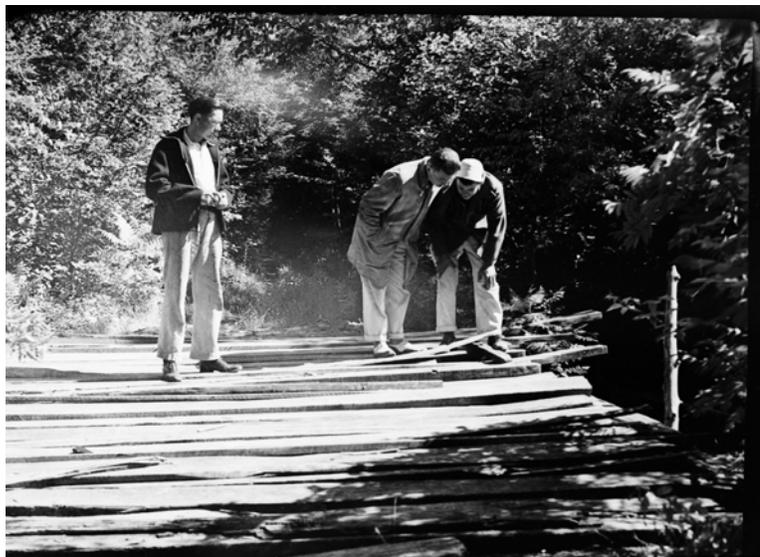
Figure 4: Original Bridge across 27 foot wide Shalda Creek

Shalda Creek is the main outflow of water from the watershed into Lake Michigan. Originally Little Traverse's outlet into Shalda Creek was 27 feet wide (Len Allgaier). In the fifties the road was paved and the logger's wooden bridge spanning it was replaced, closing the outlet down to a 42 inch diameter culvert reducing the outlet area significantly. Today, the width of Shalda Creek is 27 feet (personal communication with Len Allgaier, measured by Brett Fessel with the Grand Traverse Band of Ottawa and Chippewa Indians (GTB). Direct overland runoff to the lake is insignificant, as rainwater quickly infiltrates soils and becomes integrated with the groundwater and surface spring inputs to the lake. Thus, land use practices in the entire watershed have a much greater potential to impact water quality than is the case for many other watersheds in the State with less permeable soils.

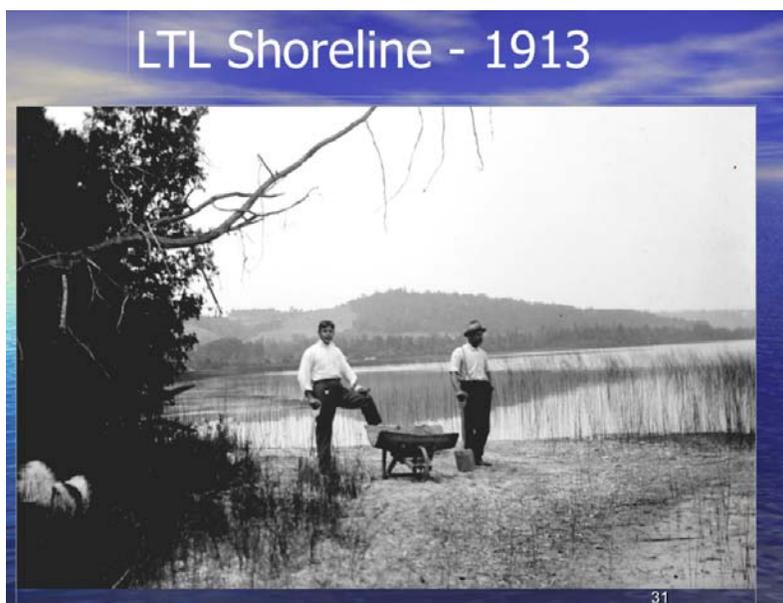
Figure 5: Original (pre culvert(s)) beach protecting shore from erosion

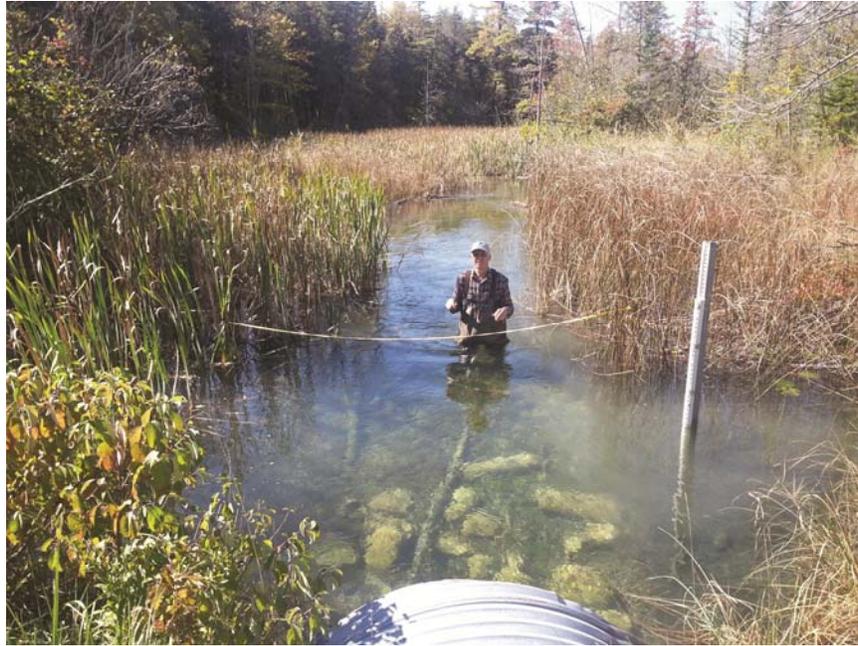
Figure 6: Fall 2014 photo of Culvert on West end of Little Traverse Lake and Shalda Creek

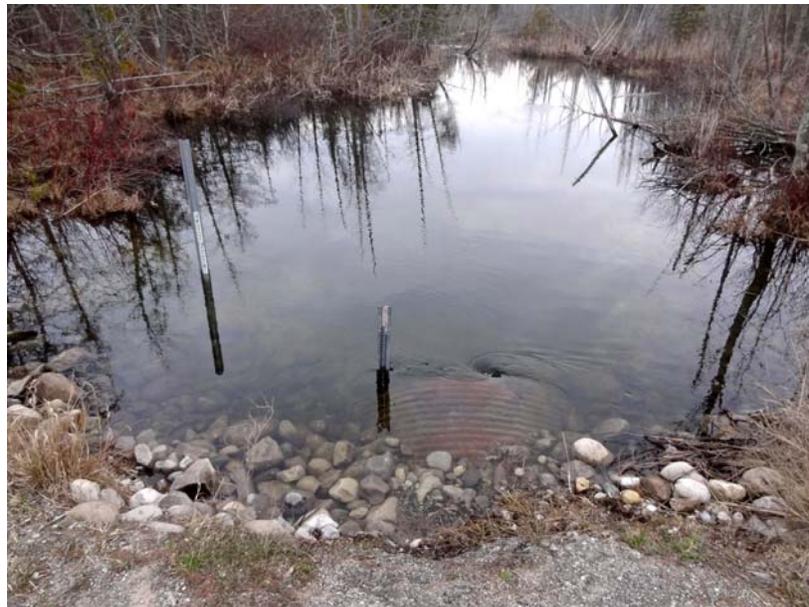
Figure 7: August 2014 photo of Culvert on County Road 669 (Shalda Creek Crossing), looking upstream towards Little Traverse Lake

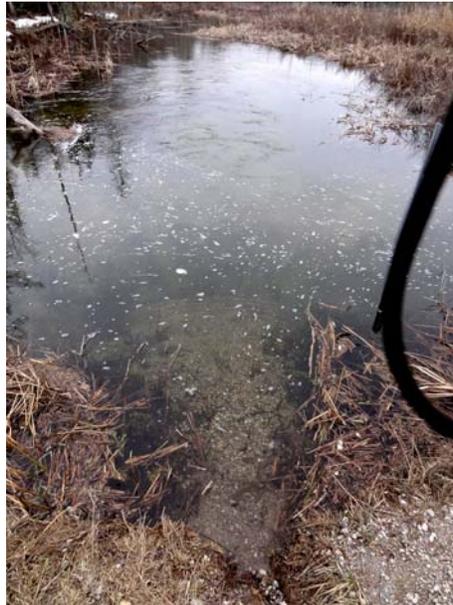
Figure 8: August 2014 photo of Culvert on County Road 669 (Shalda Creek Crossing), looking downstream

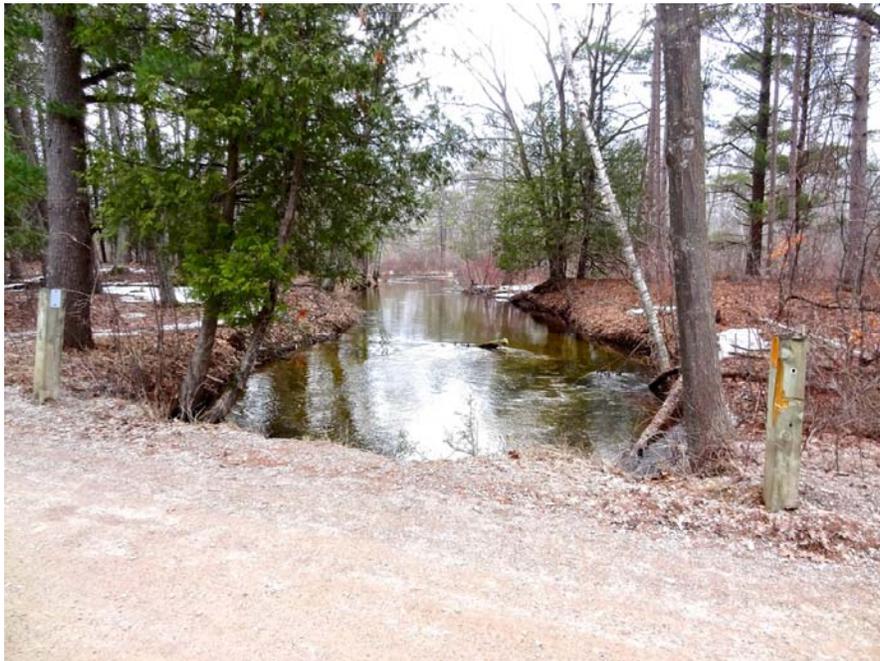
Figure 9: August 2014 photo of Culvert -County Road 669 (Shalda Creek Crossing), looking upstream

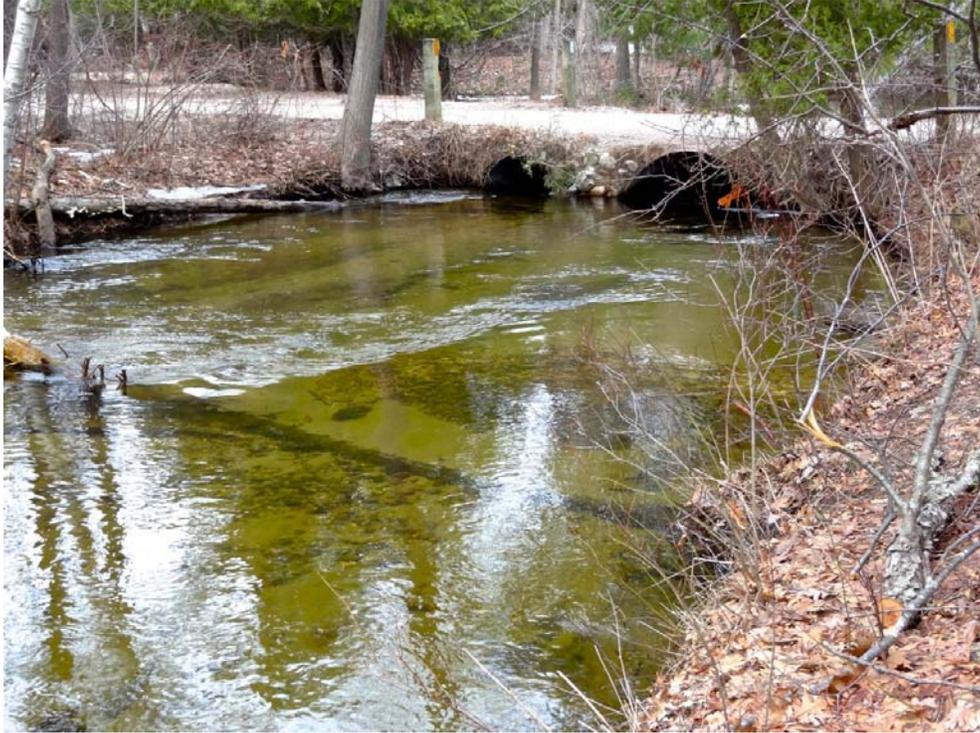
Figure 10: 2014 photo of Culvert -County Road 669 (Shalda Creek Crossing), looking upstream
